Rainbow River Environmental Study

Dunnellon, Florida

Final Report

September 2012
(Revised)

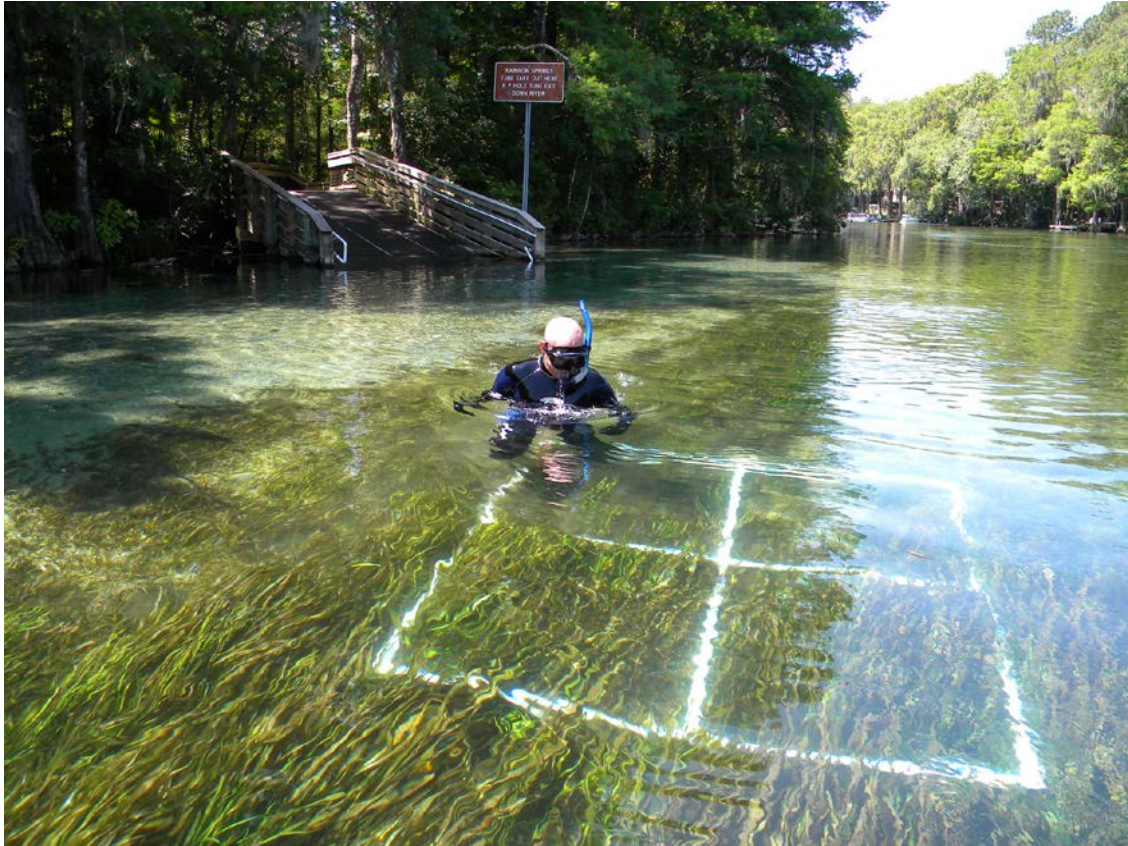
Figure 5. Jesse Stephens sampling plants in one of the 2m x 2m grids from transect 17.3 on 21 April 2011. This transect was located immediately upstream from the State Campground tuber take out. (DSCN1555)

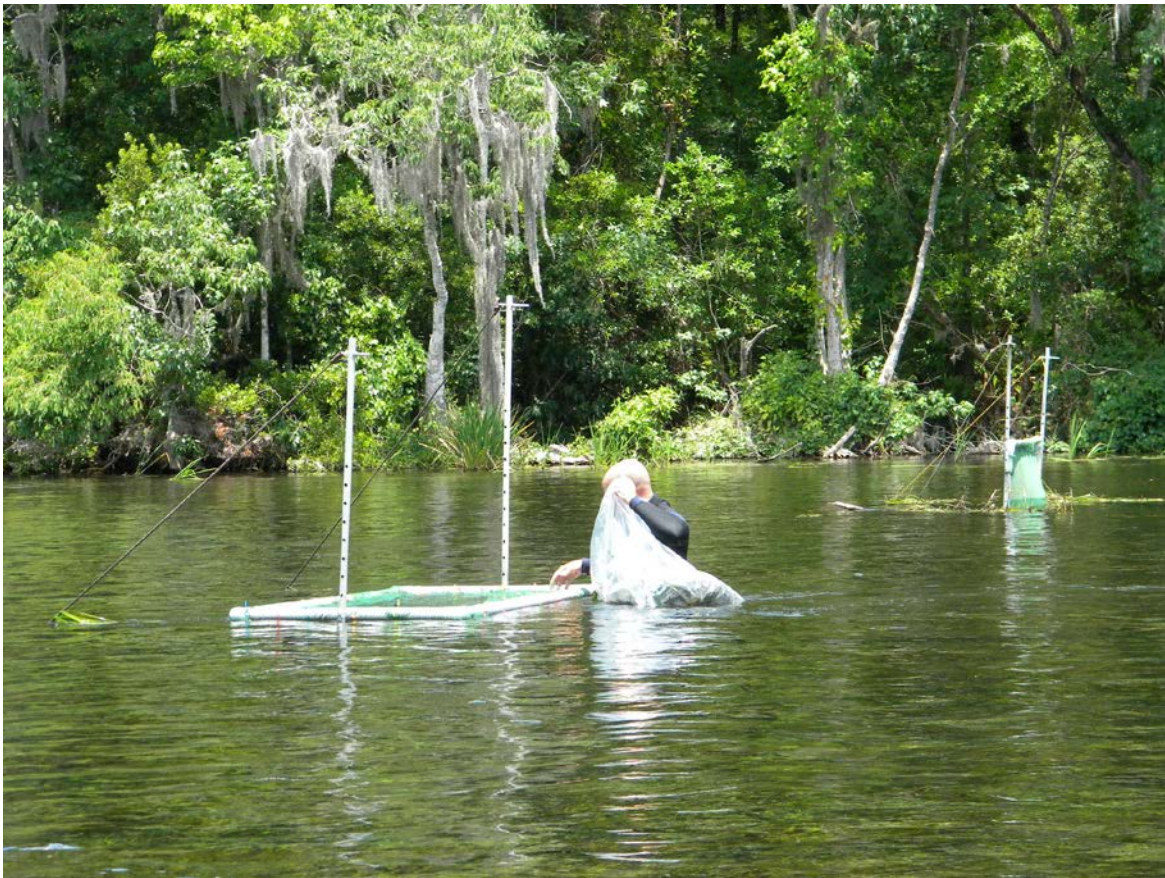
Figure 7. Jesse Stephens removing plants collected by Net 2, one of the 2m x 1m drift nets, set midstream and downstream from the KP Hole County Park on 28 May 2011. Net 3 is shown in the background, collecting plants. (DSCN1555)

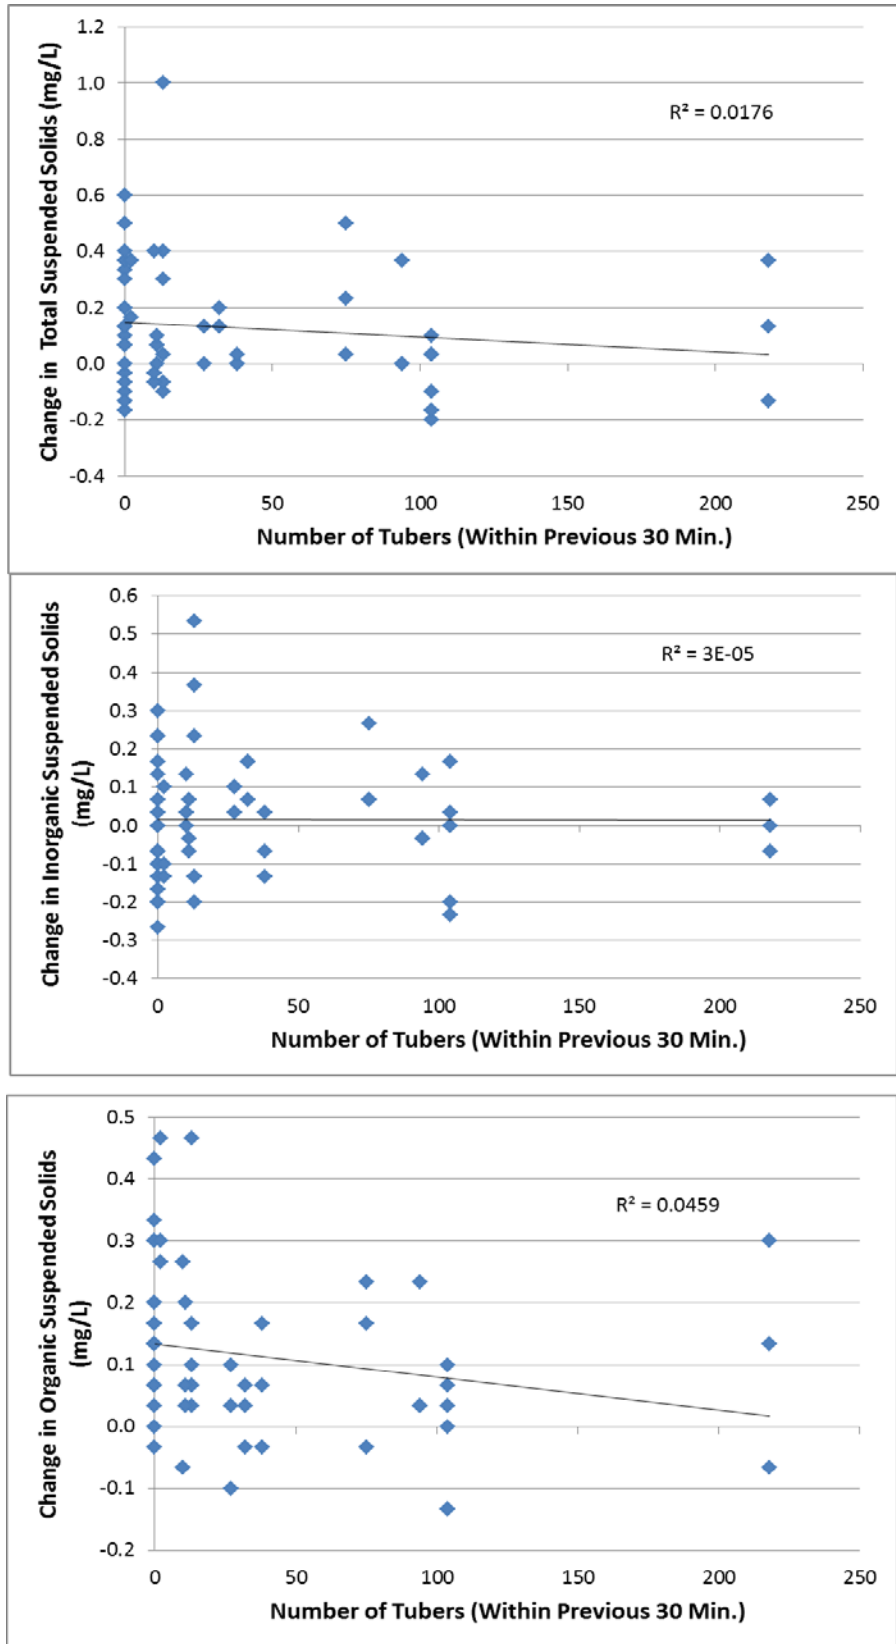
Figure 8. Change in total, inorganic, and organic suspended solids (mg/L) versus number of tubers during the prior 30 minutes of sampling below the KP Hole County Park, Rainbow River, Dunnellon, Florida, 2011-2012.

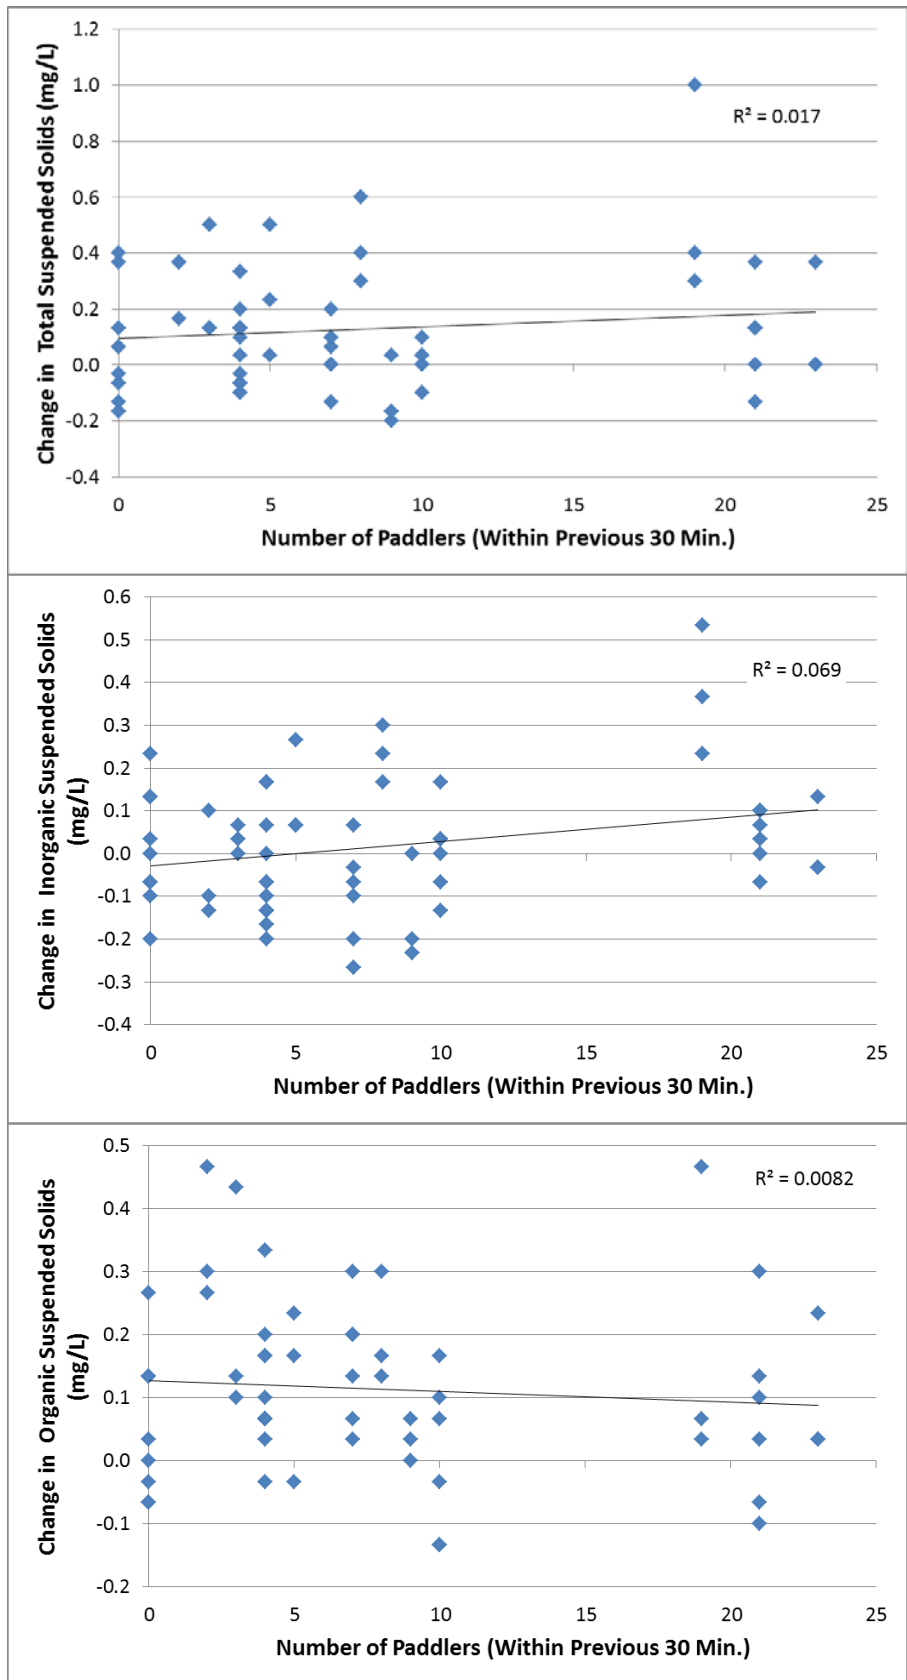
Figure 10. Change in total, inorganic, and organic suspended solids (mg/L) versus number of paddlers during the prior 30 minutes of sampling below the KP Hole County Park, Rainbow River, Dunnellon, Florida, 2011-2012.

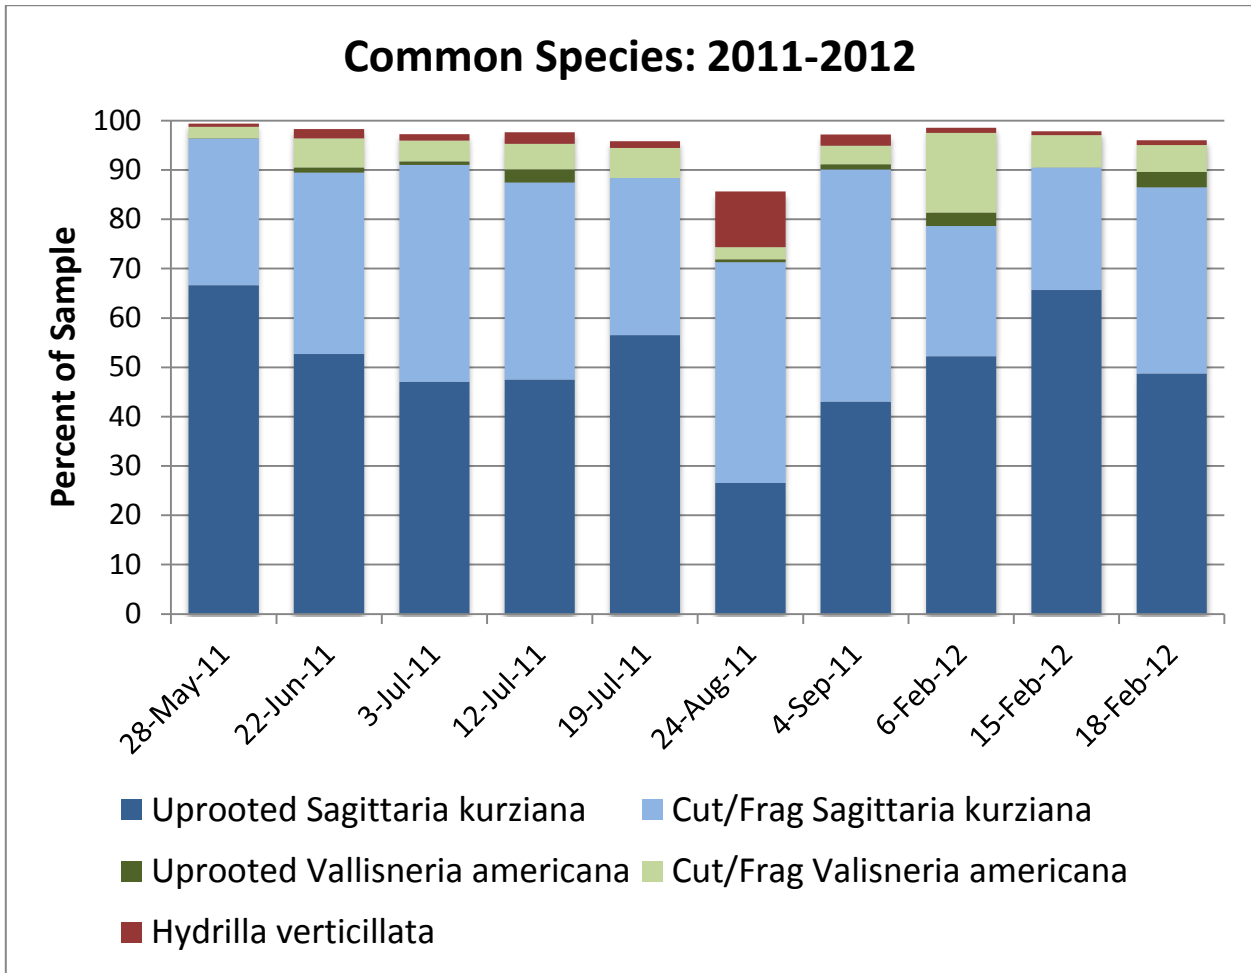
Figure 11. Relative abundance, based on wet weight, of the three most common aquatic plants collected by drift nets downstream from the KP Hole County Park on the Rainbow River, Dunnellon, Florida during 2011 and 2012. *Sagittaria kurziana* and *Vallisneria americana* are further listed as either uprooted plants or as cut or fragmented pieces of plants.

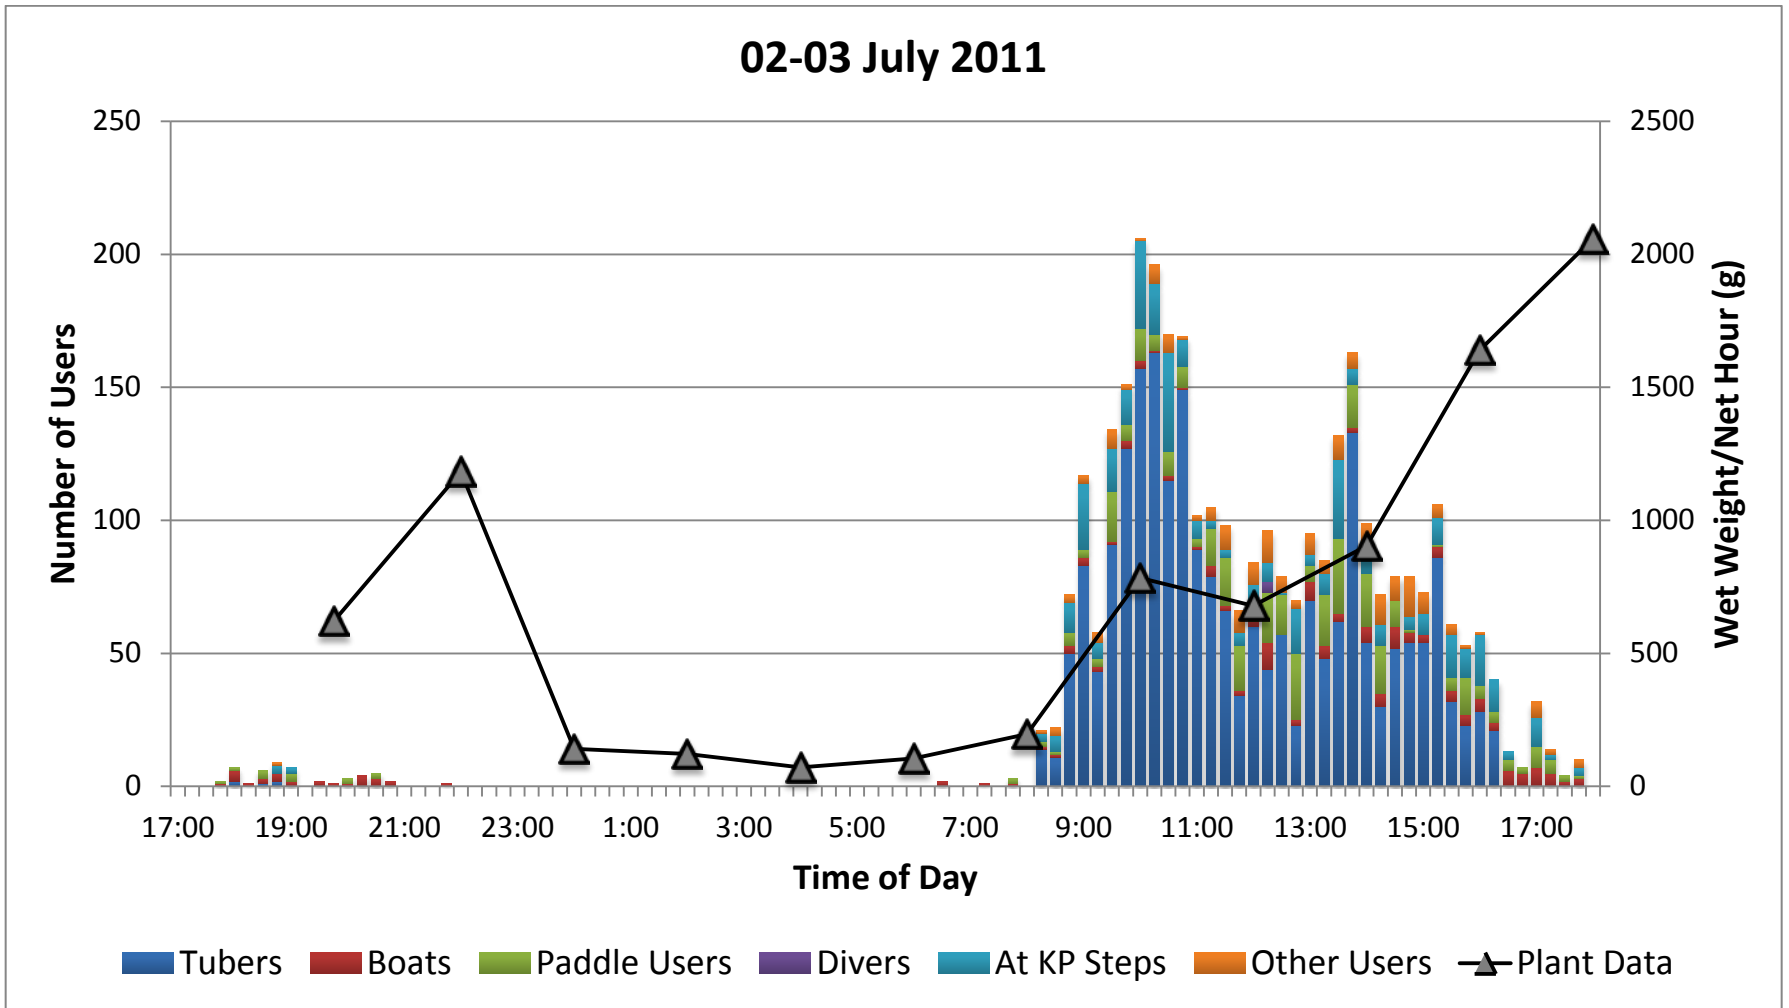
Figure 13. Number of each user group observed per 15-minutes (bars) upstream from sampling nets and mean wet weight of drifting plants collected on 02 and 03 July 2011, downstream from the KP Hole County Park, Dunnellon, Florida.

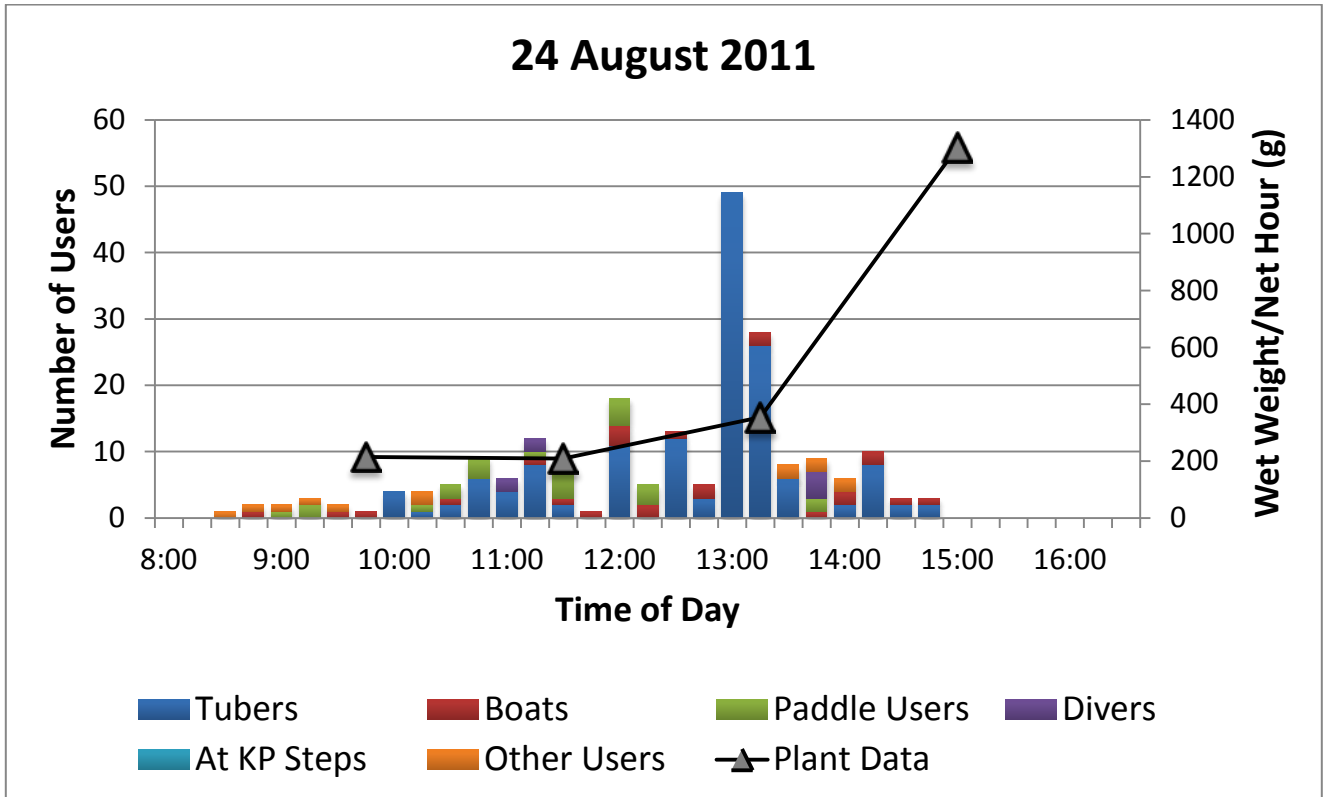
Figure 15. Number of each user group observed per 15-minutes (bars) upstream from sampling nets and mean wet weight of drifting plants collected on 24 August 2011 and 06 February 2012, downstream from the KP Hole County Park, Dunnellon, Florida.

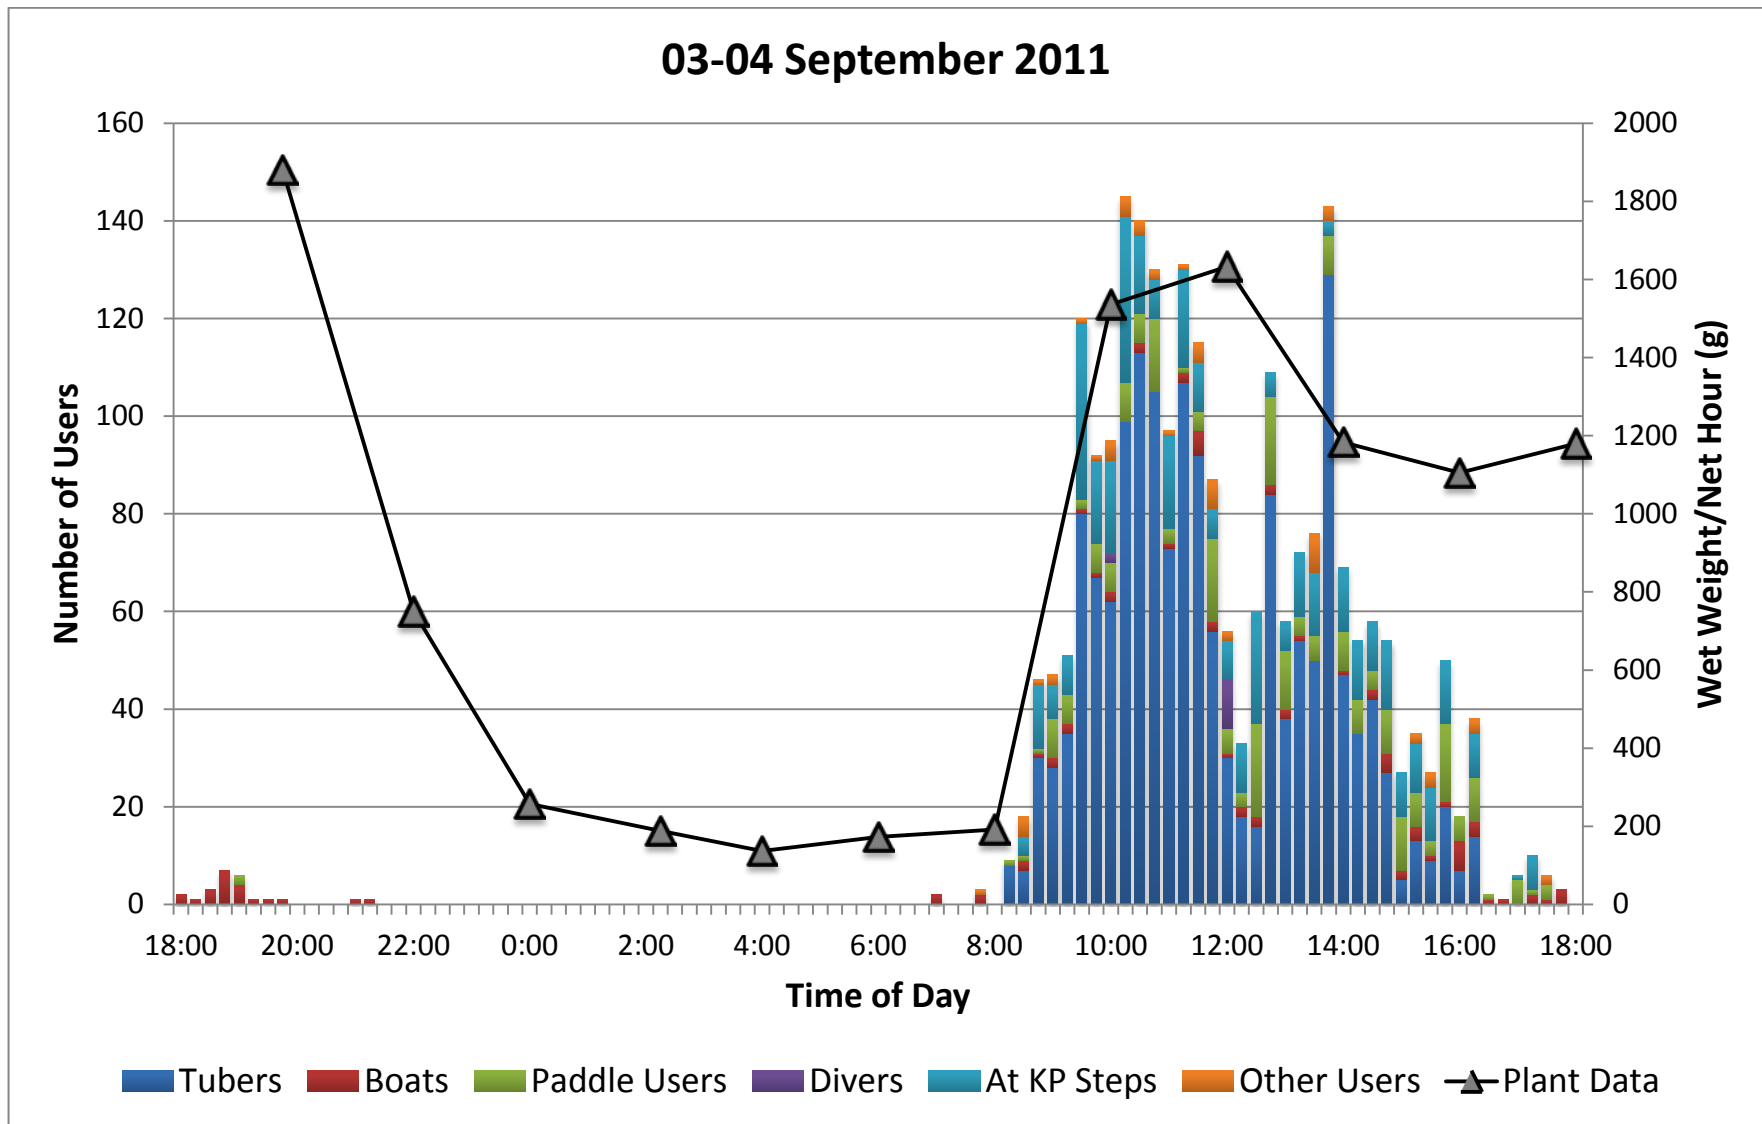
Figure 16. Number of each user group observed per 15-minutes (bars) upstream from sampling nets and mean wet weight of drifting plants collected on 03 and 04 September 2011, downstream from the KP Hole County Park, Dunnellon, Florida.

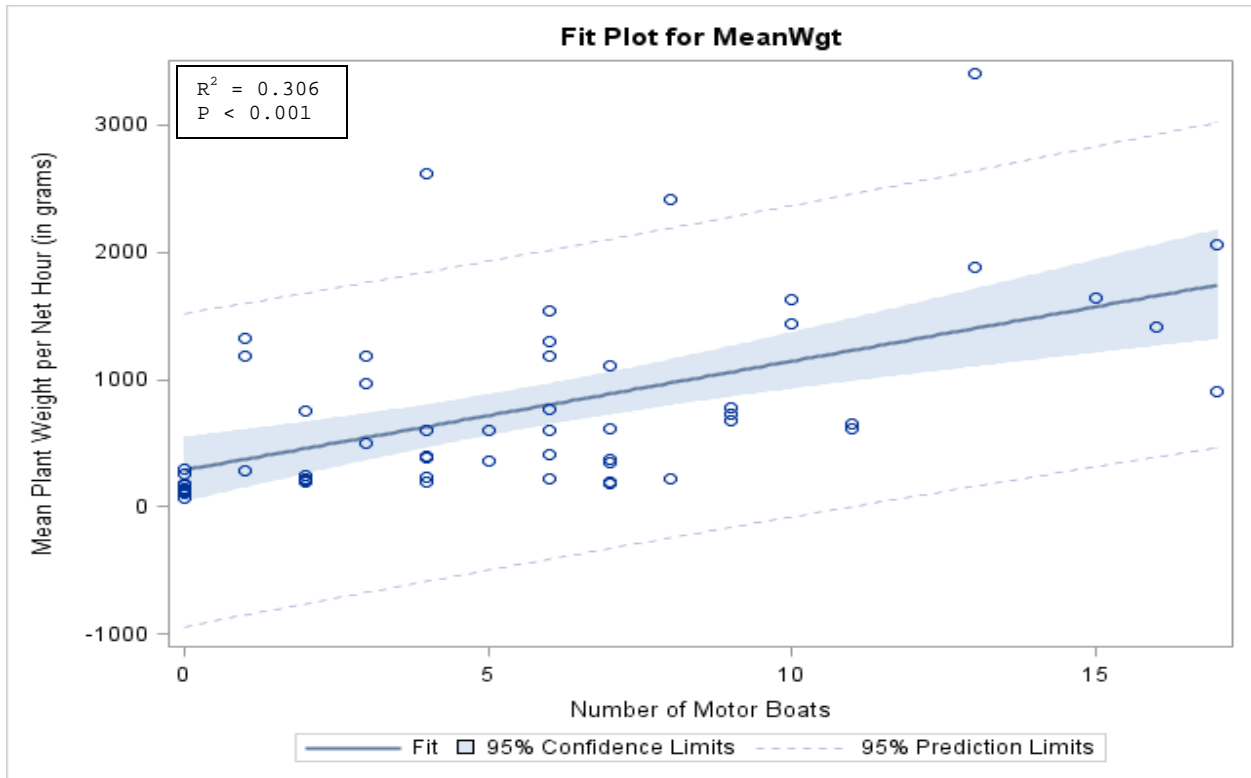
Figure 19. Plots of mean weight (in grams) and change in weight (in grams) of drifting aquatic plants collected per net hour versus number of motorized boats observed upstream from the nets during the 1-hour period of collection, just downstream from the KP Hole County Park, Rainbow River, Dunnellon, Florida, 2011-2012.

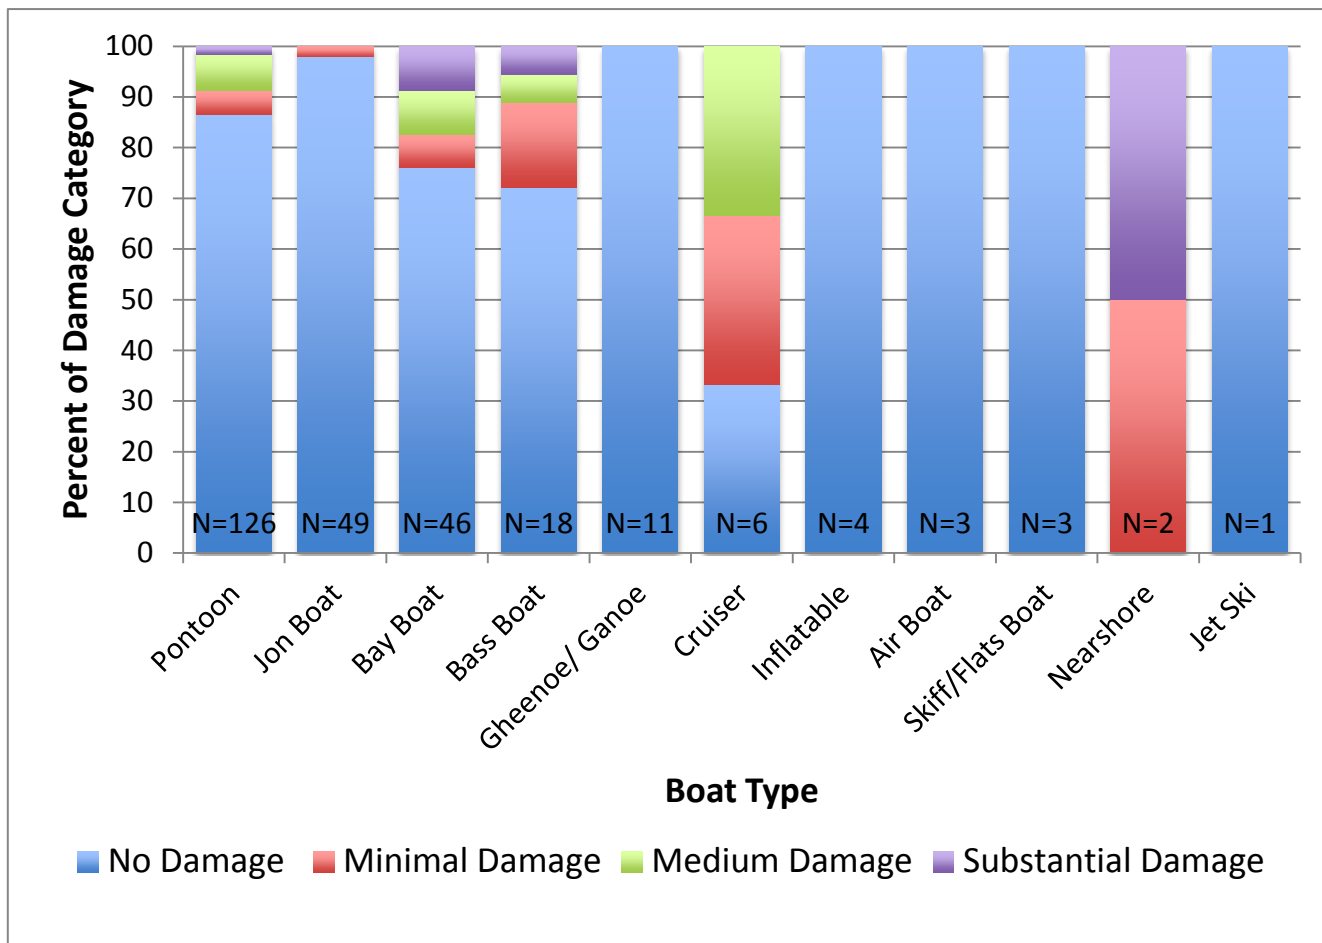
Figure 23. Relative damage to submersed aquatic plants produced by type of boat observed on the Rainbow River, Dunnellon, Florida, 2011 – 2012. Numbers in columns (N=#) are the number of boats of that type observed on the river.

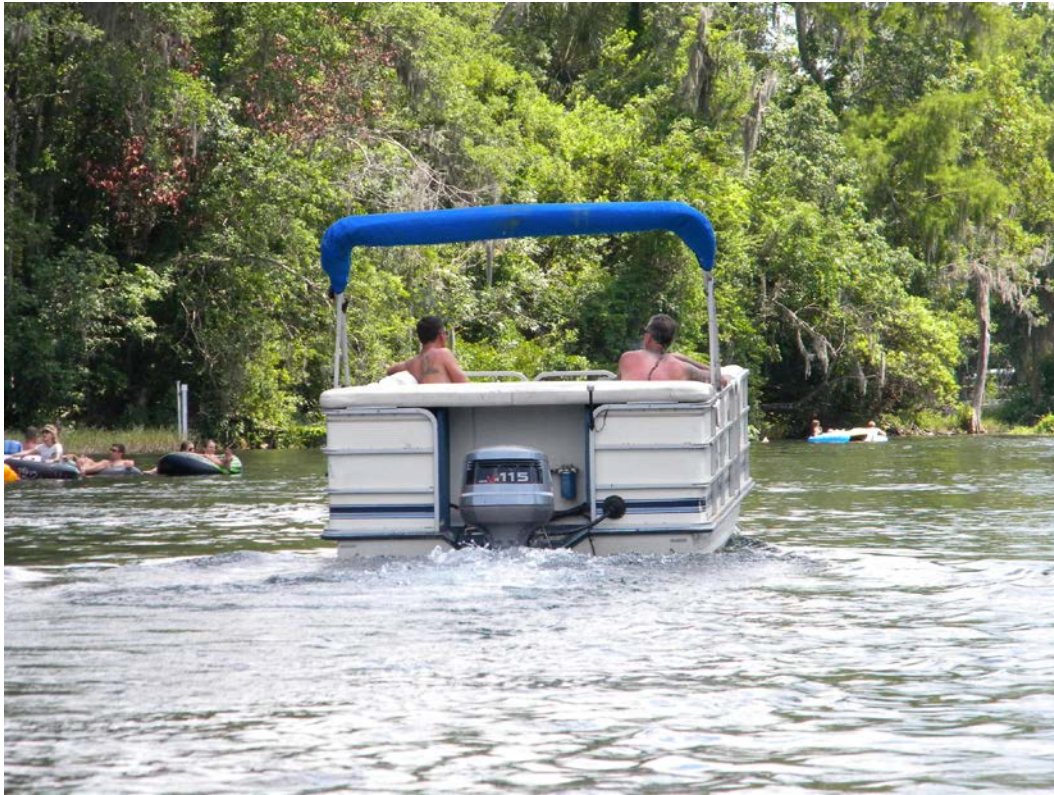
Figure 24. Photos of pontoon boat with 115-HP engine and associated plant damage and sediments caused by this boat, Rainbow River, Dunnellon, Florida, 28 May 2011. (DSCN2190 and DSCN2192)

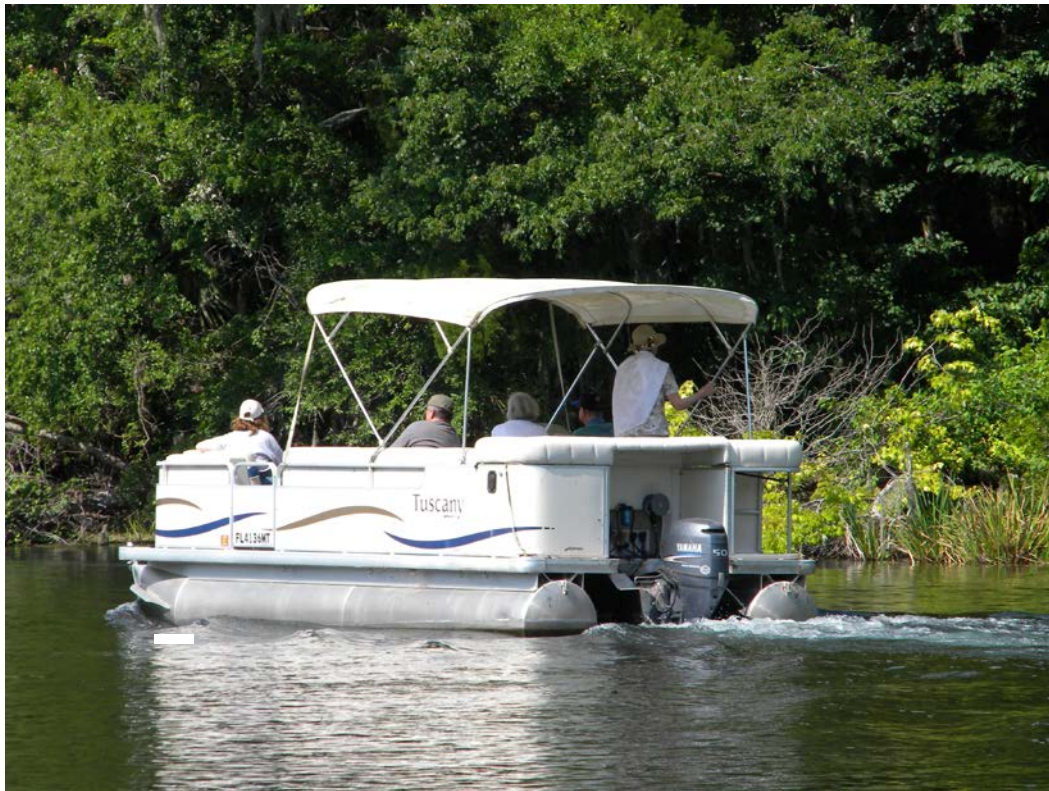
Figure 25. Photos of pontoon boat motoring along shallow eastern shore (with motor not trimmed up) and associated uprooted plant damage caused by this boat, Rainbow River, Dunnellon, Florida, 28 May 2011. (DSCN2221 and DSCN2224)

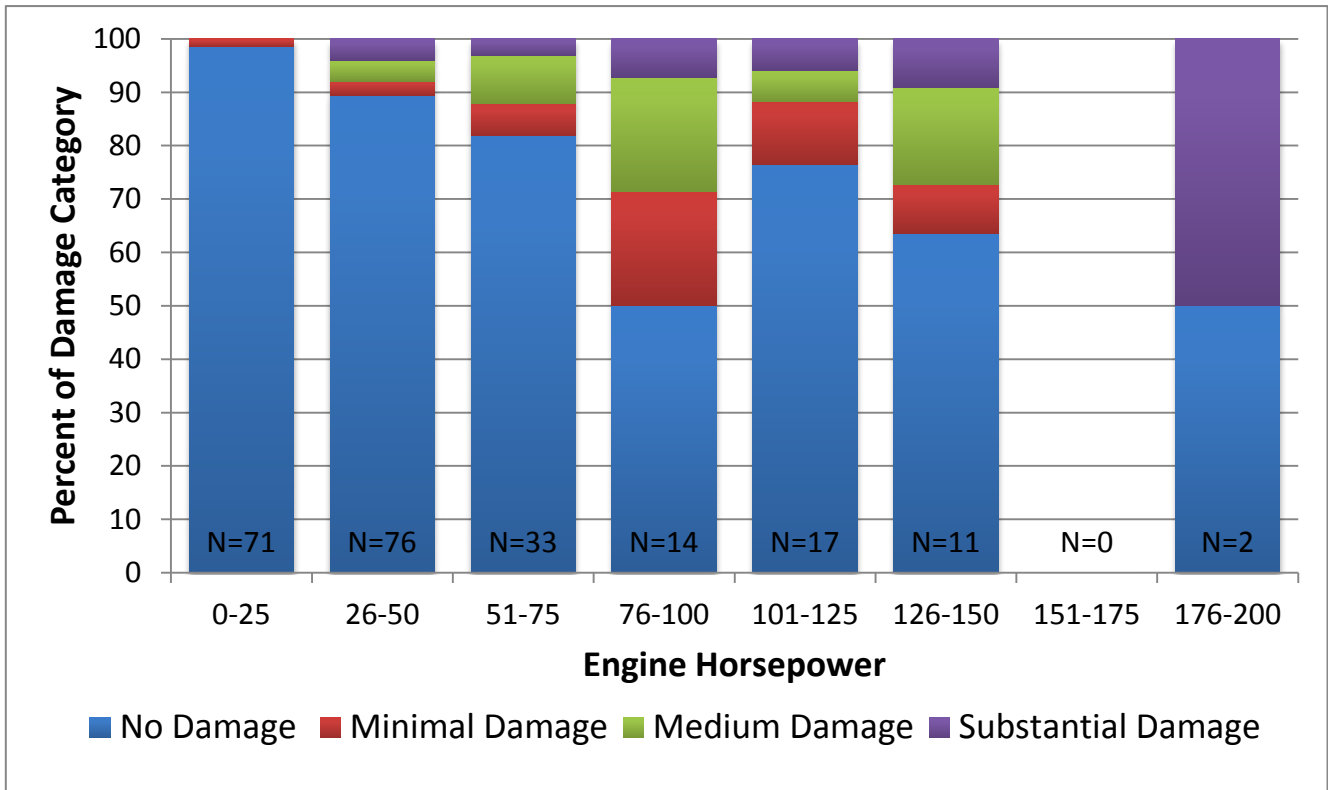
Figure 27. Relative damage to submersed aquatic plants produced by engine size (in horsepower) observed on the Rainbow River, Dunnellon, Florida, 2011 – 2012. Numbers in columns (N=#) are the number of boats with that engine size observed on the river.

When all recorded boats are combined, regardless of type or length, the overall percentage of boats causing damage and the degree of damage increased (Figure 27). The highest percentage of damage was for boats with 76 to 100-HP engines. Within this category, 4 of the 7 boats, that caused plant damage, caused it due to operator behavior and not simply due to the size of the engine. Having a large engine does not necessarily lead to plant damage. On several occasions, a boat mounted with a 200-HP engine was observed (Figure 28). This boat was never observed to cause damage, as the operator always had the engine trimmed up, the motor slowly idling, and the boat driven in the deeper portion of the river. Figure 28 also shows a second boat, with a 150-HP engine that likewise produced no damage due to the motor being well trimmed up.

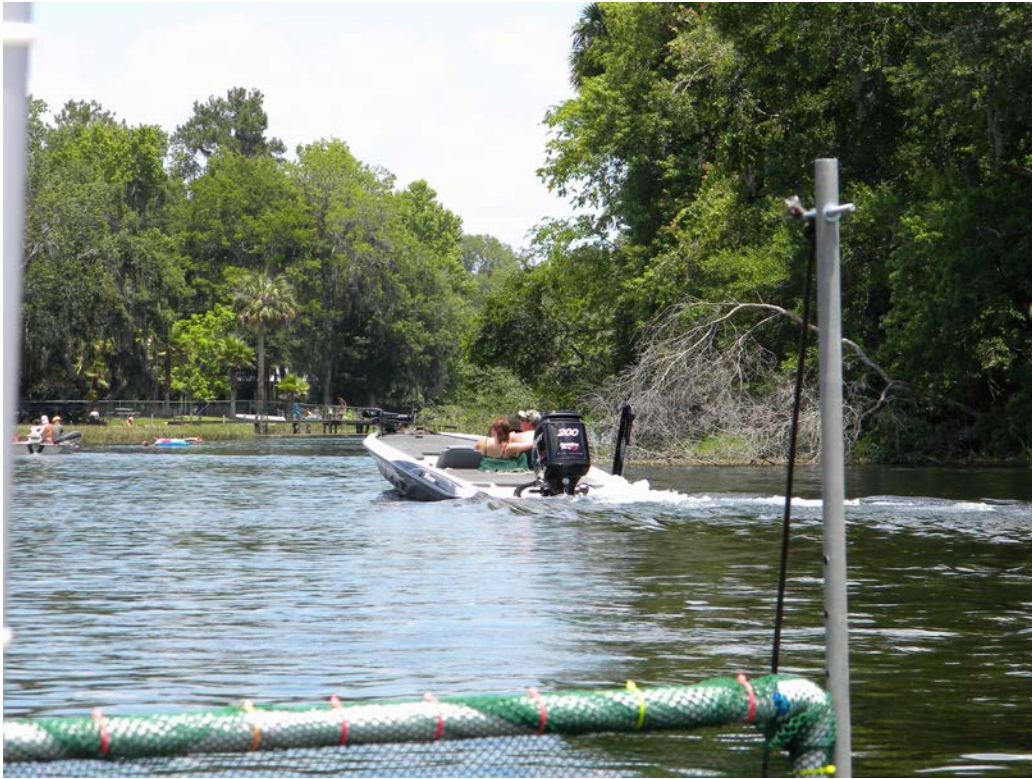
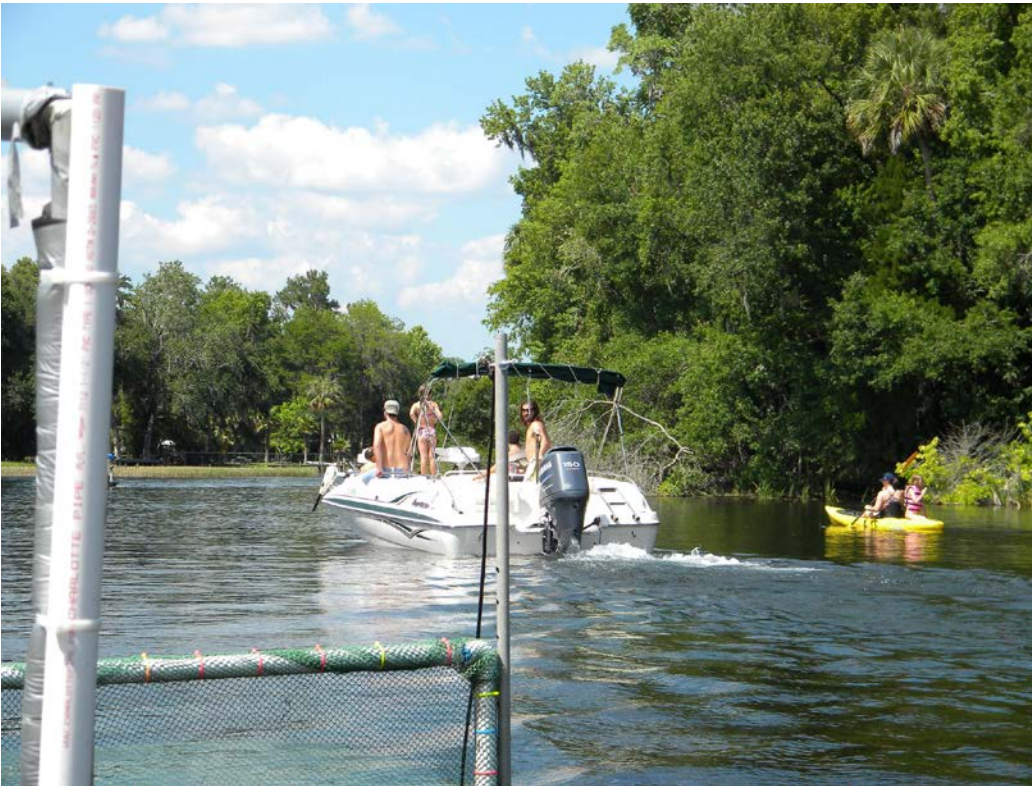
Figure 28. Examples of two boats, with trimmed-up 200 and 150-HP engines, travelling upstream due east of the KP Hole County Park, Rainbow River, Dunnellon, Florida, 28 May 2011. Neither of these boats were observed to damage plants on the river. (DSCN2155 and DSCN2209)

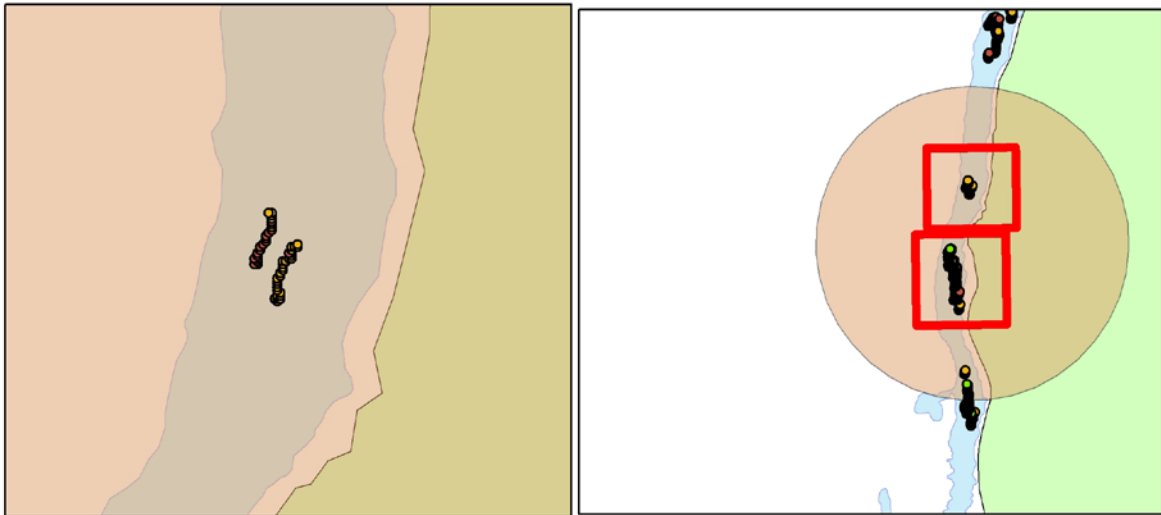
Prop Scars within State Park Tuber Take-out 1000 Foot Buffer Fall 2011

Figure 33. Map showing the location of the 14 prop scars located upstream and downstream from the State Campground tuber take out on the Rainbow River, Dunnellon, Florida, fall 2011.
